No. 35 October 1989

JDSF'S CAMP 20 VISITOR CENTER: A NEW FORESTRY EDUCATION STOP ON HIGHWAY 20

WET WEATHER LOG HAULING IMPACTS ON WATER QUALITY

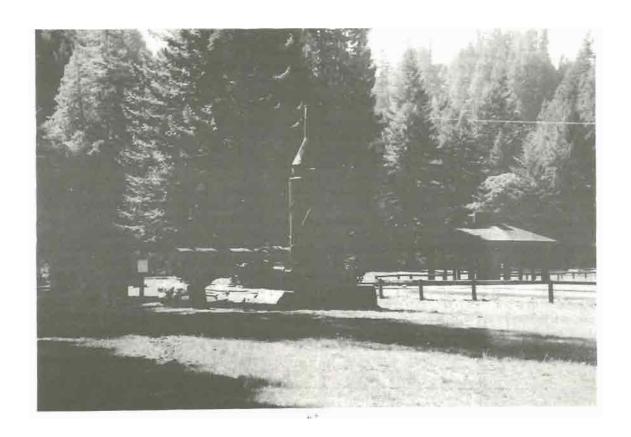
Figure 1. The Camp 20 Visitor Center.

is greatly enhanced at its new location (see Fig. 1). The donkey was cleaned and primed with marine paint and finally given a finish coat of black underbody automotive paint. Future plans include mounting it on new old-growth Douglas-fir log skids (which will be obtained from a timber sale in the North Fork of Caspar Creek), correctly mounting the water tank, and fixing the plumbing hardware. The steam donkey will probably always be a static display, as considerable effort and money would be needed to renovate it to the point where it could be fired The Mendocino County Museum at Willits does have a similar steam donkey in operating condition and demonstrates it during the July 4th holiday.

The next stage of development at Camp 20 was to construct a redwood beamed open air information center. The original design was borrowed from a vintage 1930's National Park Service structure.

Our building, however, was con-structed with large sawn timbers, while the plans specified unsawn logs. The intent was to build a structure which would accentuate the big timbers and still provide an open, well lit display area. The central rectangular column was planned as part of the display system. Each side has a case which contains either graphic and text materials, or other physical objects specific to Jackson Demonstration State Forest. Fire Crew Supervisor Carlos Farre constructed the structure and the woodworking shop at Chamberlain Creek Conservation Camp built the display cases. The displays are intended to be temporary and will be rotated about twice a year. Currently, a second set of displays have been created and installed in the cases. Subjects range from silvicultural techniques to recreational opportunities on the Forest.
